# **The Combined Sewer Overflows of Rock Creek**

**Where They Are; When They Flow**

**Marchant Wentworth  
Wentworth Green Strategies**

**September, 2021**

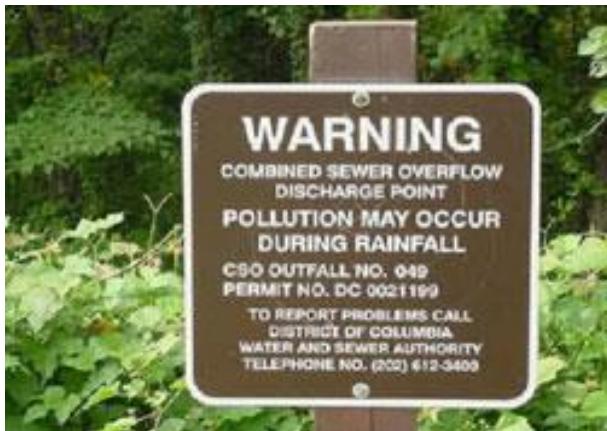
Figure 1. Under the terms of the Consent Decree, each CSO outfall is required to have a small brown and white sign identifying the outfall by number and explaining what it is and warning of polluted water. As the vast majority of the CSO structures are on land controlled by the National Park Service, any identifying sign, even one required by the Long Term Control Plan, must conform to the Park Service signage protocols.

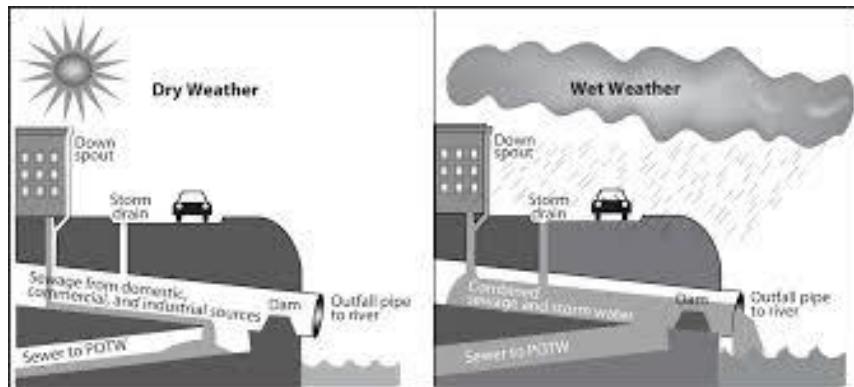
Figure 1. This schematic illustrates generally how CSOs work to pollute nearby waterways

The combined sewer is an antiquated sanitary engineering artifact that attempted to solve the perpetual problem in sanitary engineering: how to accommodate the huge volumes of stormwater and wastewater as quickly and cheaply as possible and with minimal disruption to the neighborhood. This system combined wastewater from toilets and baths in the same pipe with stormwater from roofs and streets by confining the wastewater to a central sunken channel in a middle of the larger pipe (see Figure 1). During dry weather, as long as the sewage is contained in the channel, the wastewater flows, usually by gravity, to the treatment plant. But during rainstorms, the pipes fill rapidly and the sewage laden wastewater overtops its channel and flows into the nearest water course.

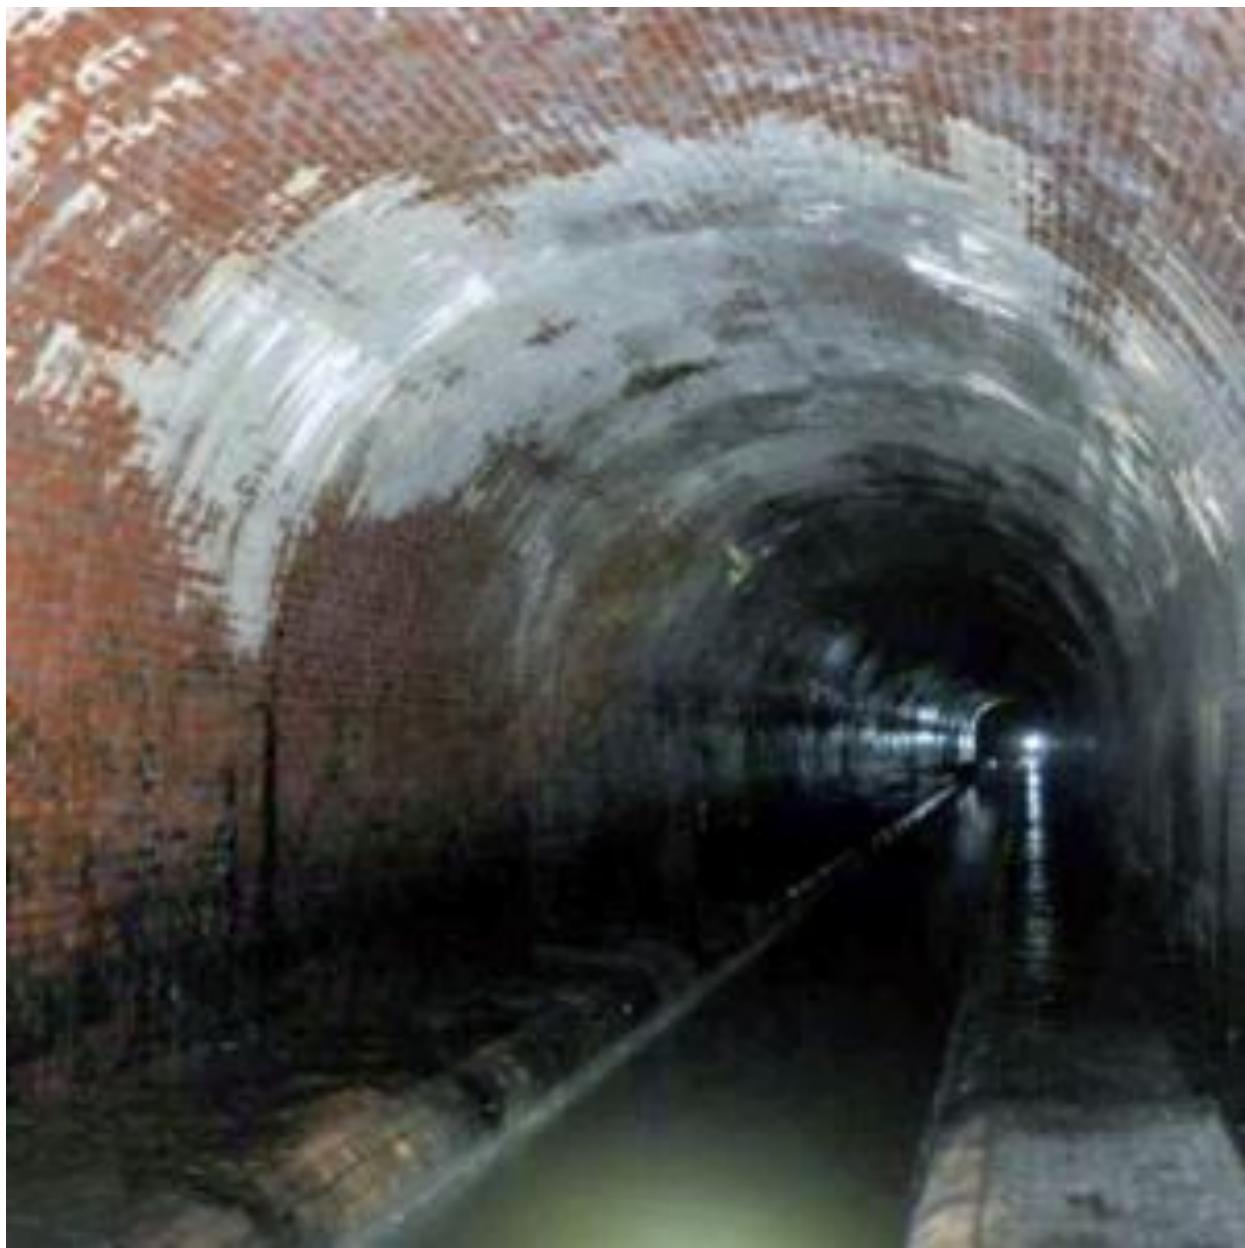
**FIGURE 2. INSIDE THE TIBER CREEK COMBINED SEWER, JANUARY 2017. THIS TYPE OF SEWER FEATURES A CENTER CHANNEL OR CUNETTE THAT IS OVERARCHED BY MULTIPLE COURSES OF BRICK DURING HEAVY RAINS, THIS ENTIRE TUNNEL WILL FILL WITH COMBINED SEWAGE.**

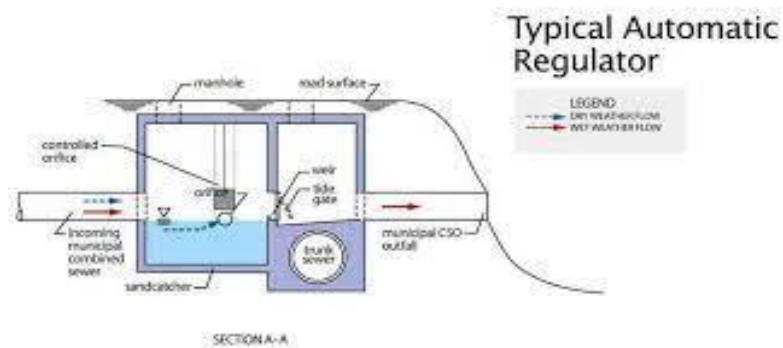
Figure 3. This regulator has a float that opens a valve when the flow of combined sewers reaches a certain level.

To relieve the volumes of wastewater and protect the sewer system from being overloaded, CSOs have special valves that open during heavy rains (and sometimes not so heavy rains) to disgorge the contents of the pipe, now mixed sewage and rainwater, into the nearest waterway. This protects the sewer system but grossly pollutes the nearest creek or stream. The flows out of these pipes are controlled by CSO regulator structures.

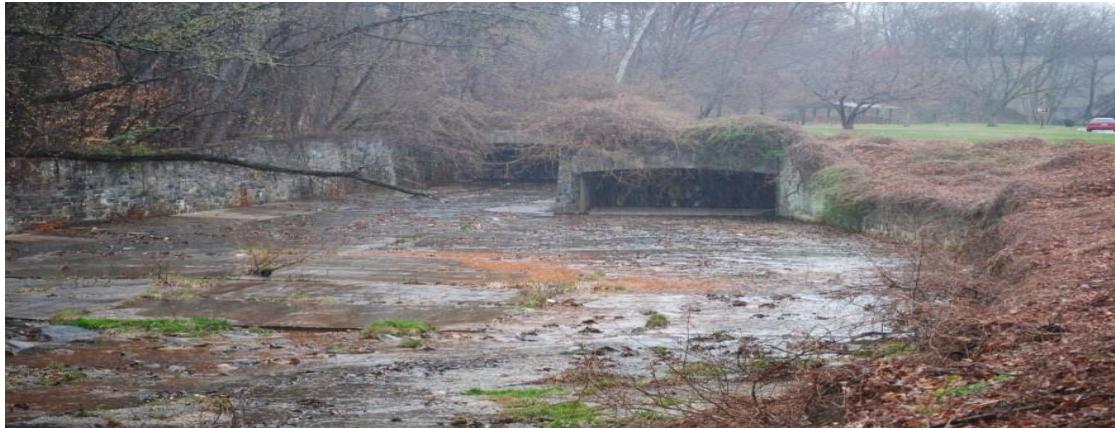
**Figure 4. This combined sewer overflow outfall, CSO 49, is the largest in the system. During heavy rainstorms, this spillway can fill up completely due to its massive catchment area of over 2,500 acres. Photo by author, 2014.**

DC Water has been grappling with what to do about CSO 49 for decades and has made some progress. Now, during dry weather a weir directs much of the flow of CSO 49 to the West Rock Creek Diversionary Sewer which connects to CSO 21 that discharges to the Potomac. Originally, the LTCP contemplated a giant 23 foot storage tunnel on the north side of Piney Branch, similar to that planned for the Anacostia and the Potomac to retain the overflows and send them to the treatment plant after the storms. But in January, 2016, DC Water proposed a hybrid Green Infrastructure (GI) approach that would employ the extensive use of GI such as green roofs, rain gardens and permeable pavement to reduce or retain stormwater. But after evaluating the results of two projects in the sewershed, in June, 2020, DC Water concluded that the cost of applying GI to the entire treatment area of 365 acres was more than the cost of a tunnel and that there was not enough public land available to install enough GI to meet the water quality goals of the program. In April, 2021, DC Water received approval from EPA for its "Practicality Assessment" that concluded that attaining the necessary acreage of GI was not possible. This new agreement requires an additional 2.1 MG of stormwater retention to be built, gives a credit of 2.3 MG of stormwater credits from public and private landowners, and requires

an additional 4.2 MG storage facility to be built. These actions were predicted to limit the overflows at Piney Branch to one per year and the rest of the outfalls on Rock Creek to no more than 4 overflows annually – all by 2030. As of September, 2021, the project is awaiting an Environmental Impact Statement as the project would likely be sited on National Park Service land.

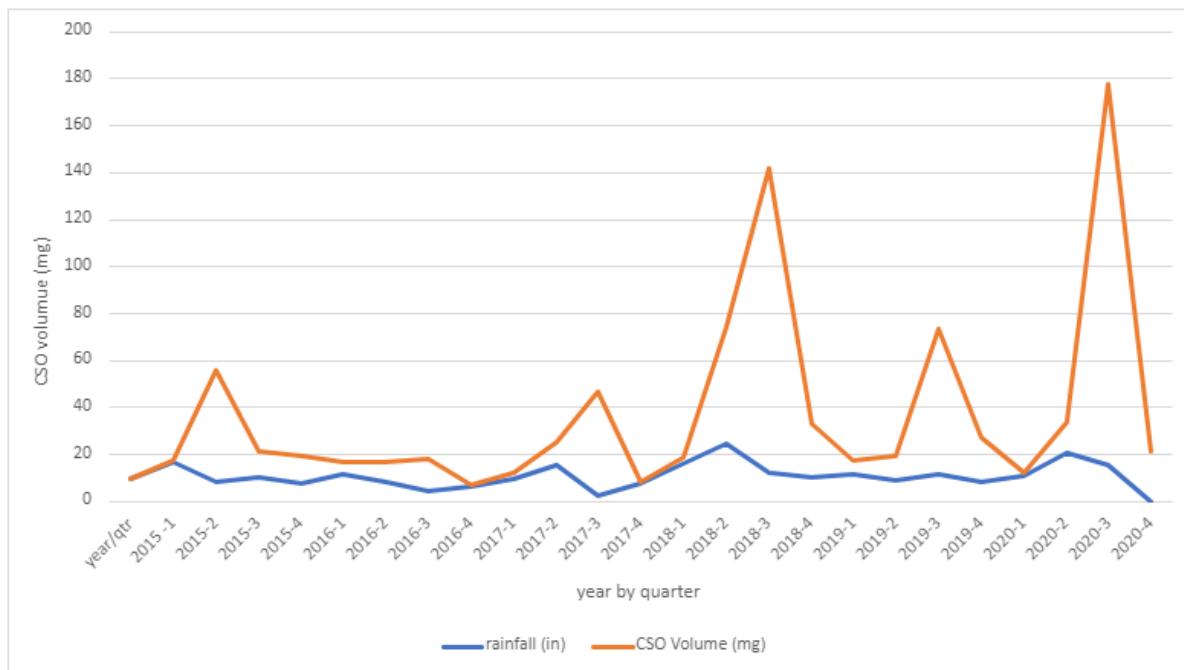
**FIGURE 3. ROCK CREEK CSO vs RAINFALL**

**Figure 2. Relatively small changes in rainfall can result in large increases in CSOs. Typically, the 2nd and 3rd quarters are the wettest and create the most CSOs.**

The following Figure 5 shows the relationship between rainfall and Rock Creek CSO volume. While CSO volumes generally trend with rainfall, the relationship is far from linear.

During the five year study period, five distinct peaks of rainfall appear, with the second and third quarters of 2018, 2019, and 2020 being the wettest of the quarters and producing the largest volume of overflows.

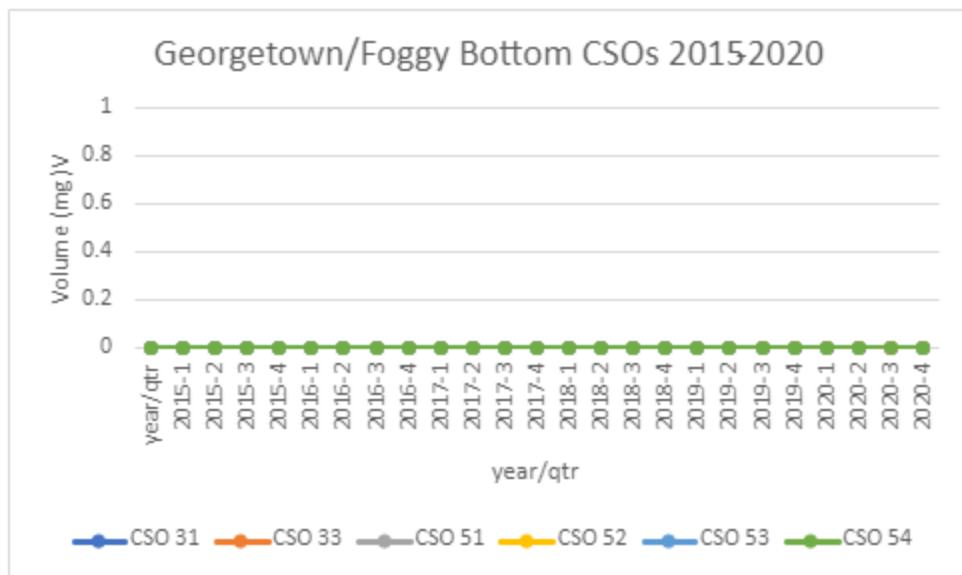
## **Georgetown/Foggy Bottom/West End CSOs 2015-2020**

The first two CSOs (31 and 32) on the east bank of Rock Creek have no discharge to the creek. CSO 31, underneath the Pennsylvania Ave Bridge, has been separated, and CSO 32 has no discharge over the study period. CSO 33 on the east bank of Rock Creek in the West End neighborhood near 25<sup>th</sup> and N Streets was only slightly active, releasing 4.89 million gallons (MG) of combined storm and wastewater over the five year period and releasing 2.45 MG in the wet 2nd quarter of 2020 alone. (See Appendix Table E). This CSO was only active in the second quarters of 2018, 2019 and 2020, relatively wet quarters. The sewershed area of CSO 33 is composed of only 11 blocks in the West End neighborhood (3.08 acres) and extends from N St NW on the north, M St. on the south, 24<sup>th</sup> St on the East and 25<sup>th</sup> St on the West. In the nineteen fifties, this area was mostly light industrial, with car repair and car dealerships. It is now replete with condominiums, offices and hotels. This relatively large discharge of this CSO is surprising for a comparatively small sewershed. Earlier reports indicated that this CSO acted primarily as a relief overflow for the Rock Creek Main Interceptor but DC Water staff now reports that the regulator structures have been adjusted to reduce the overflow.<sup>12</sup> However it is clear from the quarterly reports that overflows, however slight, continue.

The remaining CSOs in this neighborhood include one on the west bank at Olive Street in Georgetown, two on the west bank at O St and one further upstream on the west bank 300 ft. south of the Massachusetts Ave Bridge. As the graph below indicates, none of these appear active. The discharges to this area of Rock Creek from West End downstream to the mouth of Rock Creek are relatively slight. This means that this portion of the creek is relatively clean.

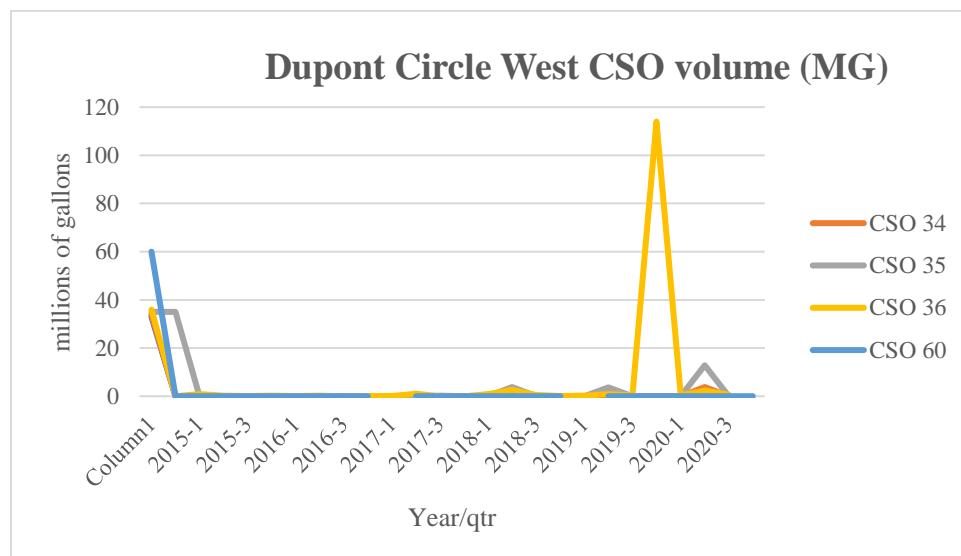
## The CSOs of Dupont Circle West

Of the four CSOs in this area, by far the heaviest discharger is CSO 35 located under the P Street Bridge, discharging over 20.6 MG during the study period — the majority of it in the wet 2<sup>nd</sup> and 3<sup>rd</sup> quarters of 2017, 2018, 2019 and 2020 (See Appendix Table G for details). Aside from the massive overflow volume of CSO 49 on Piney Branch, CSO 35 is the second largest discharger on the creek. Just upstream from CSO 35, also underneath the Q St Bridge is CSO 36, the fourth largest discharger on Rock Creek, which was active during the wettest 3<sup>rd</sup> quarters of 2018 and 2020 but releasing only about 12.5 MG. Because these two outfalls are immediately upstream of “P Street Beach,” a popular gathering place in the summer, they pose a particular threat to water contact in that area – particularly after rain storms.

The sewersheds of these two CSOs are some of the largest on the creek—and therefore difficult to control. In the case of CSO 35, also known as NW Boundary Sewer, to picture the extent of the sewershed of 546.69 acres, think of a giant funnel extending northeast from Dupont Circle to Adams Morgan, north up 16<sup>th</sup> St to Columbia Rd, east to 14<sup>th</sup> St. and south to R St. Only CSO 34, also known as Slash Run, rivals it in the size of its drainage area of 473.34 acres.. In the case of CSO 36, that sewershed drains 69.76 acres and extends along Embassy Row along Massachusetts Ave. and northeast to the Kalorama neighborhood.

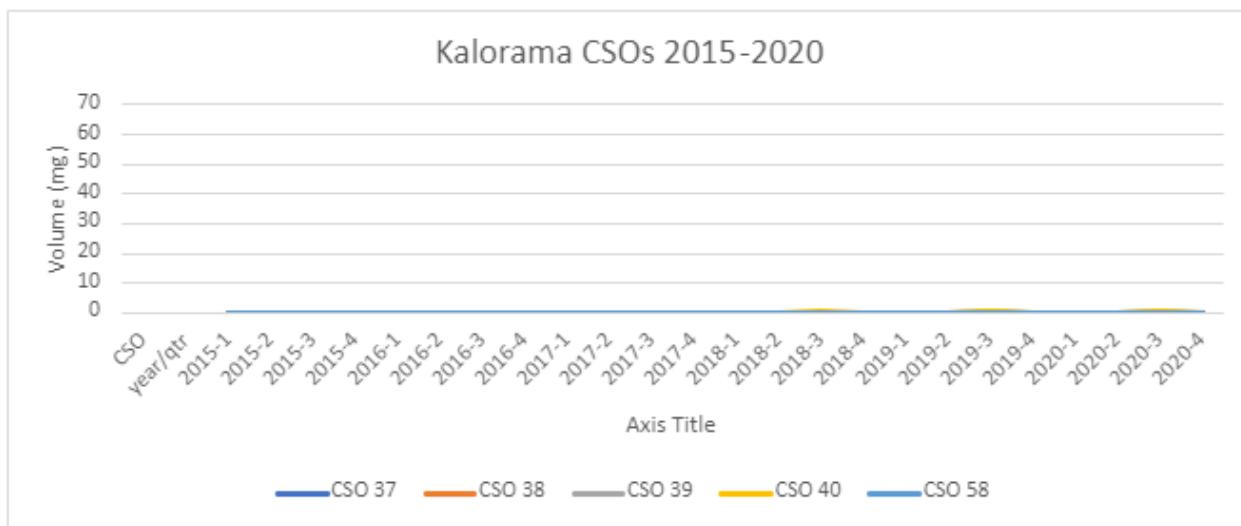
## The Kalorama CSOs 2015-2020

The five CSOs in the Kalorama neighborhood of Rock Creek are quiet compared to others in the system. Two of them, CSO 37 and 53 have been separated. Of the three remaining, CSO 38 discharged only a negligible 0.0001 MG during the five year study period – hardly noticeable compared to some of the others in the system. CSO 39, underneath the Connecticut Ave Bridge, discharged slightly less than 1 MG while CSO 40 at Biltmore St extended, was the most active, releasing 1.5 MG during the same period. All of these overflows generally only occurred during the wettest quarters of 2018, 2019 and 2020.

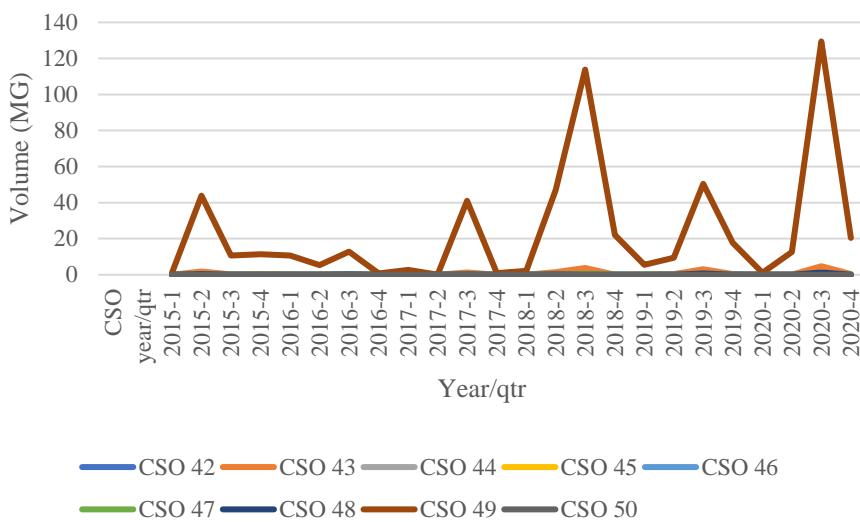
## Mt. Pleasant CSOs Volume 2015-2020

Of the remaining CSOs in the Mt. Pleasant neighborhood, CSO 43 is the main offender, releasing 18.14 MG of overflow making it the third largest in the system and second only to Piney Branch in the Mt. Pleasant neighborhood. Located just upstream of the Harvard St Bridge, it serves 20.31 acres of portions of the row house neighborhood of Mt. Pleasant. The next largest discharger, CSO 48, drains the small catchment area of Oak St. and Mt Pleasant St. (2.5 acres) and released only 3.62 MG over the five-year period.

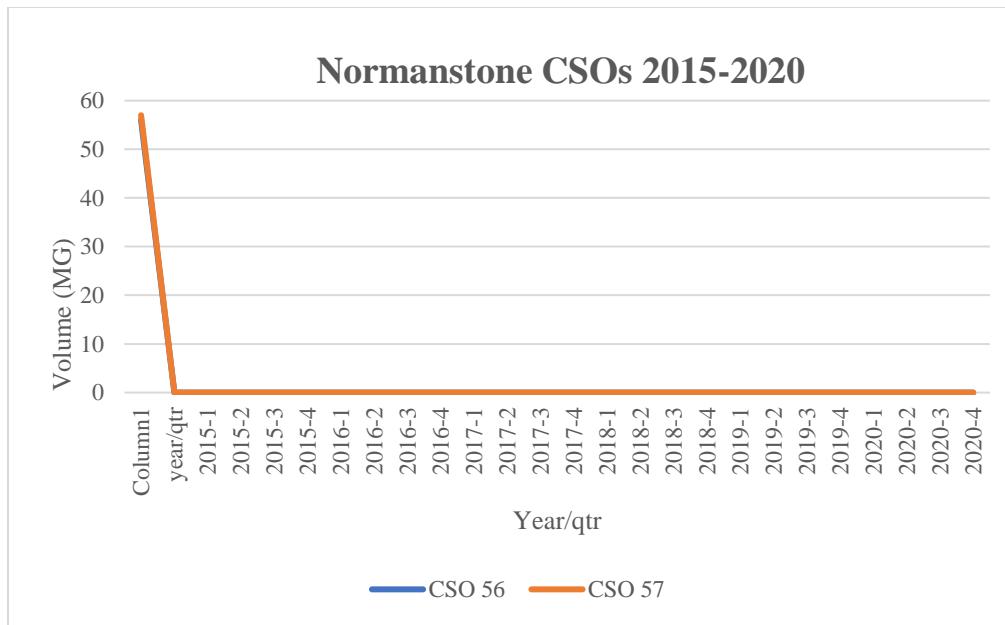
## Normanstone CSOs

Although this valley of stately single family homes suffers from leaking sewers, the two CSOs contributed no overflows during the five year study period. This not to say the neighborhood is spared from the onslaughts of pollution: surveys by the Anacostia Riverkeeper Network reveal consistently high bacteria counts in the Normanstone tributary there. This is consistent with the problem of leaking sewers in the area that have plagued the neighborhood for years.
